## APPENDIX B – PHOTO LOG

Site Conditions Photolog for Lake Drive FA Study

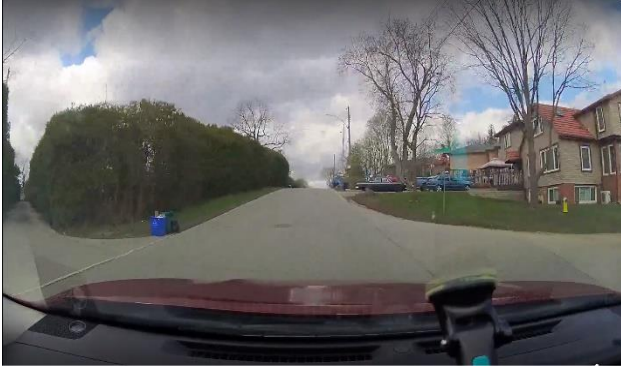
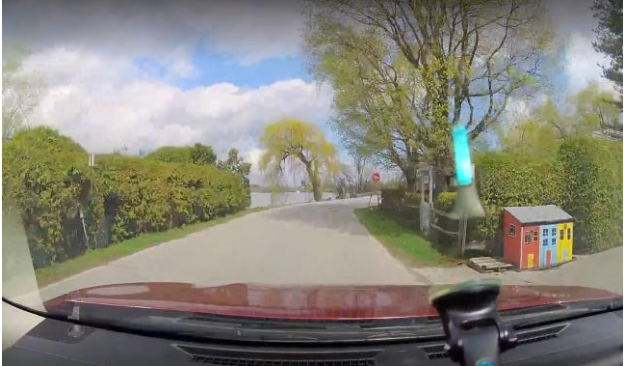
<p><b>Sightline Concern:</b></p> <ol style="list-style-type: none"> <li>1. Uphill driving: Vertical sight obstruction</li> </ol> <p><b>Location:</b> Lake Drive North – Elmview Gardens Intersection</p>	<p><b>Sightline Concern:</b></p> <ol style="list-style-type: none"> <li>1. Sharp turn on right</li> <li>2. Sightline obstructed by trees</li> </ol> <p><b>Location:</b> Lake Drive North – Clarlyn Drive Intersection</p>

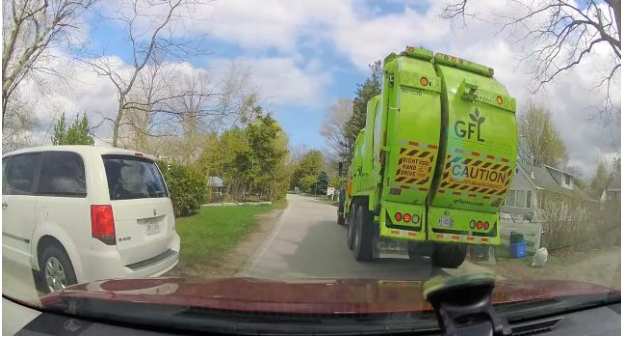
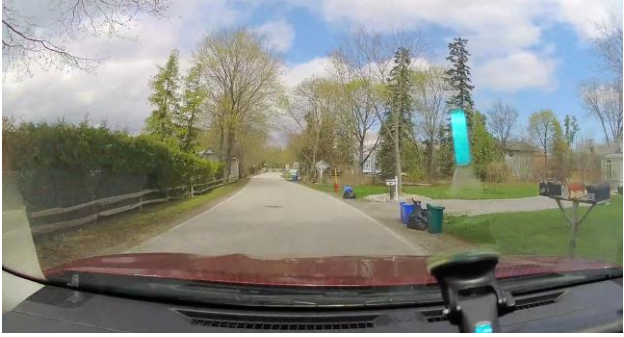
<p><b>Observation:</b></p> <ol style="list-style-type: none"> <li>1. Not enough space to pass garbage truck</li> </ol> <p><b>Location:</b> Lake Drive North – Orchard Beach Intersection</p>	<p><b>Observation:</b></p> <ol style="list-style-type: none"> <li>1. Lots of Potholes</li> </ol> <p><b>Location:</b> Along Lake Drive North Road</p>

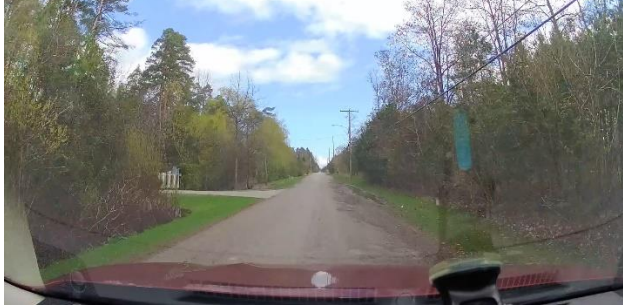
<p><b>Observation:</b> 1. Cracked Pavement</p> <p><b>Location:</b> Lake Drive North – Mays Wharf Road Intersection</p>	<p><b>Observation:</b> 1. Lots of Potholes</p> <p><b>Location:</b> Along Lake Drive North Road</p>

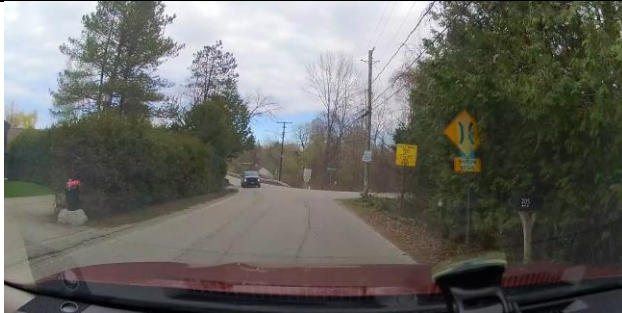
Hedge Road – Sibbald Cres. Intersection

**Sightline Concern:**

- 1. Sightline obstructed by trees on both sides

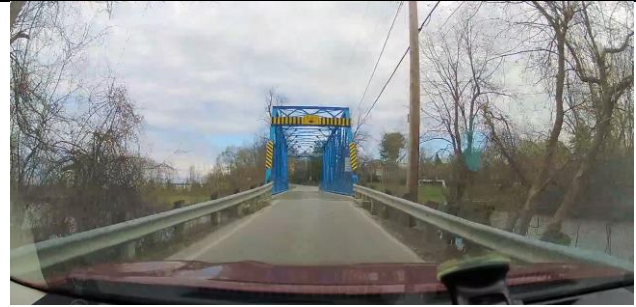
Hedge Road – Sibbald Cres. Intersection

- 1. 35m long Bridge

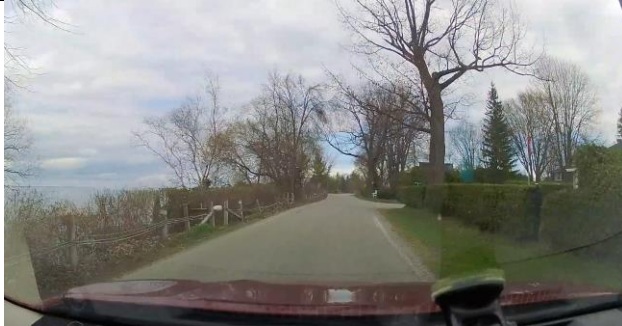
Hedge Road – Dunkirk Avenue Intersection

**Sightline Concern:**

- 1. Sightline obstructed by trees on the right

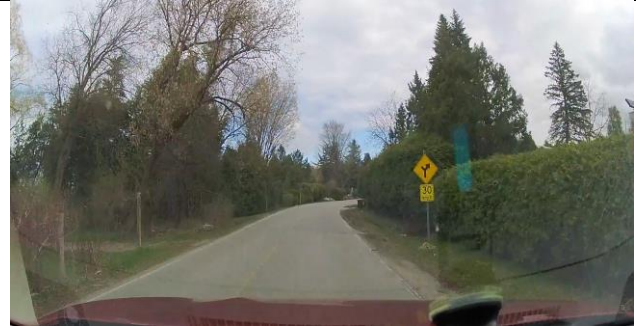
Hedge Road – Seaward Drive Intersection

**Sightline Concern:**

- 1. Sightline obstructed by trees on the right
